Material Matters

High-temperature ceramic coating protects boiler tubes from slag deposition and corrosion

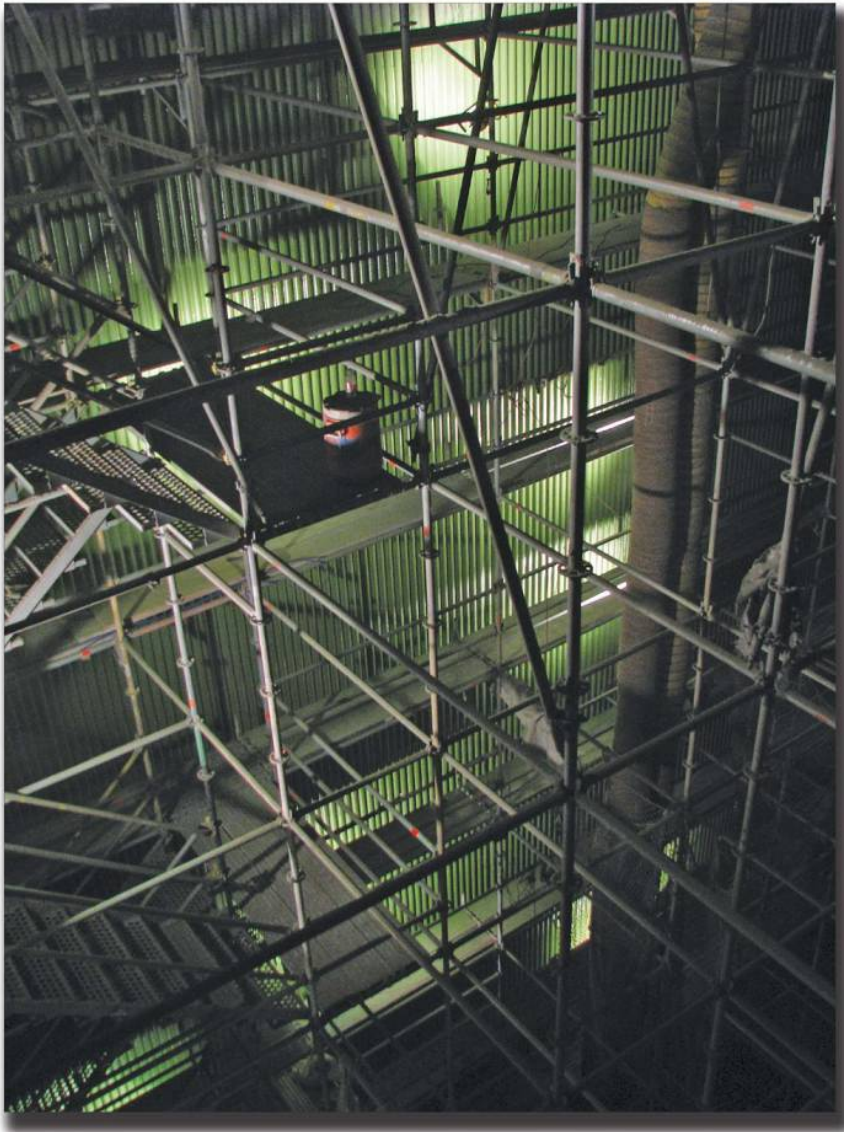
Boiler water wall tubes in this combustor were recently coated with a green, high-temperature ceramic coating. Temporary scaffolding is used to spray-apply the coating as well as service the boiler. Photo courtesy of Antonio Liberatore, FMP.

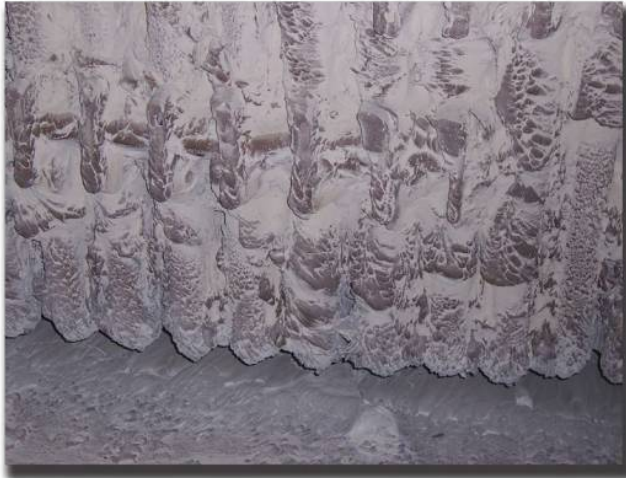
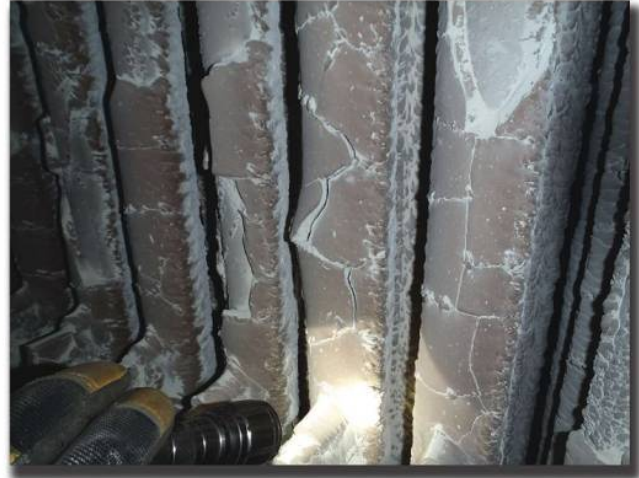
Before being coated, superheater boiler tubes in the Rosebud Operating Services' power plant in Billings experienced severe slag build-up (left) that was removed by sandblasting. After coating the superheater boiler tubes, slag buckles and breaks off (right). Photos courtesy of Dan Gray, Rosebud Operating Services.

Gray applied the ceramic coating to boiler tubes in the combustor at the Colstrip plant and in the superheater in the Billings plant. He observes that slag adheres to the coating rather than the boiler tubes, making it simpler to remove. “Slag will stick to the tubes; there is nothing you can do to stop it. But it comes off a lot easier than before,” Gray says. Previously, slag was removed by chipping and abrasive blasting. Now the slag is removed by shaking the tubes. “Before we started using the ceramic coating, we spent \$300,000 per year trying to reduce the agglomeration and subsequent corrosion,” Gray remarks. “If we hadn’t gotten to the point of protecting these tubes, we would have eventually seen a substantial amount of damage and would be looking at \$1 million to replace them,” he says.

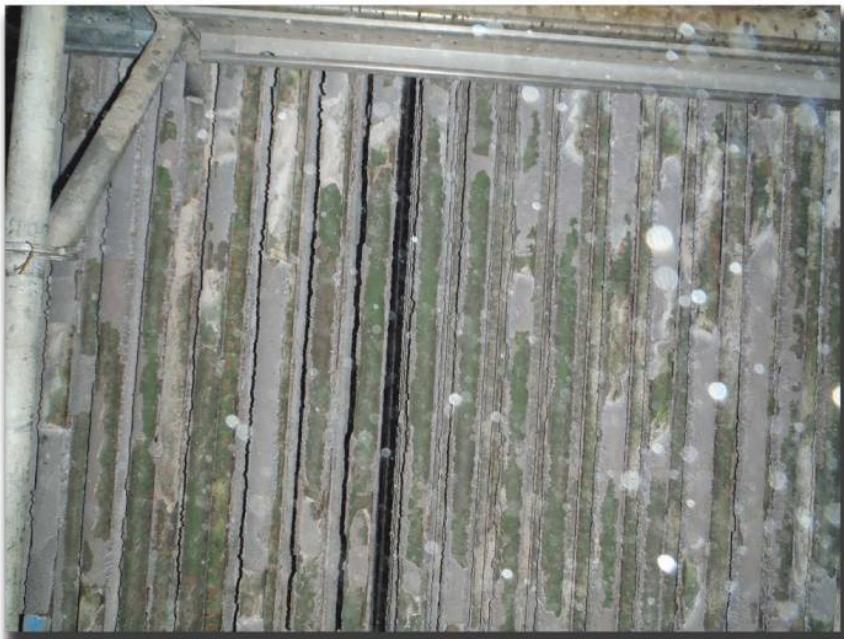
Coated superheater tubes are shaken to remove slag. Underneath the slag, the green ceramic coating is visible. Photo courtesy of Dan Gray, Rosebud Operating Services.
